Manhole Inspection Summary

Manhole # S33C__022MH

Location Address: **314 tyson st**

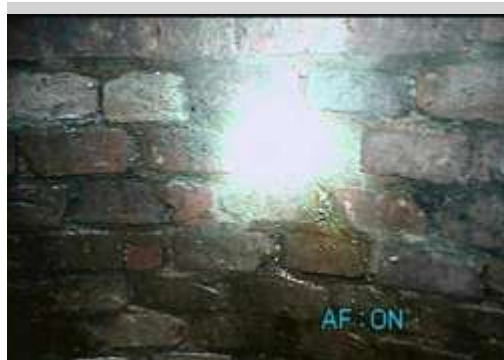
Defect 4

bench debris

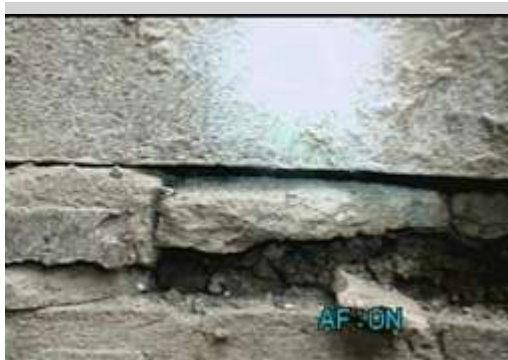
Defect 2

barrel infiltration at wall

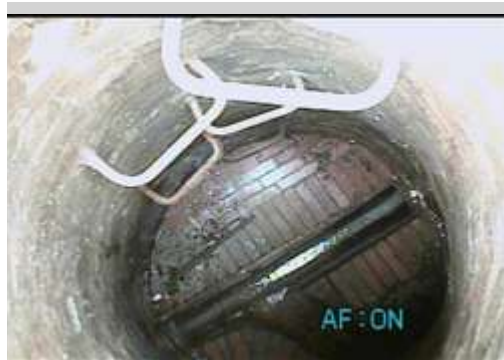
Defect 1

chimney loose brick, deteriorated

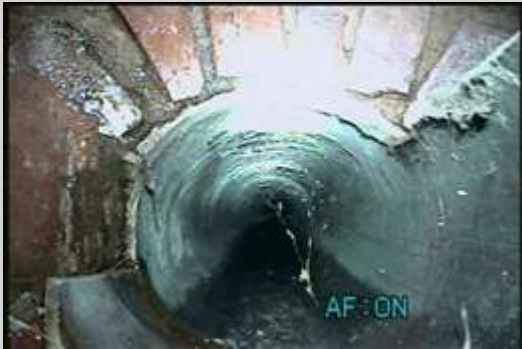
12 O'Clock Outflow

8 in. Circular Gravity Sewer
Pipe Out @ 12 O'Clock

Invert Depth: **9.32** (ft.) Flow Characteristics: **Slow**

Infiltration: **None** Pipe Seal Cond: **Unknown**

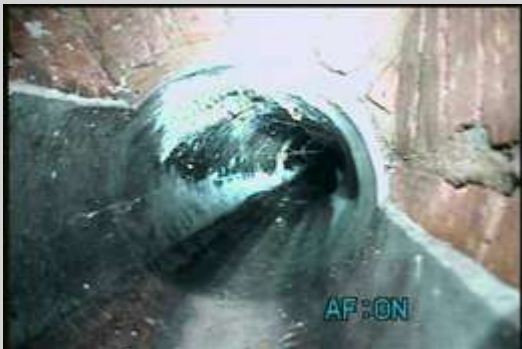
6 O'Clock Inflow

8 in. Circular Gravity Sewer
Pipe In @ 6 O'Clock

Invert Depth: **9.15** (ft.) Flow Characteristics: **Slow**

Infiltration: **None** Pipe Seal Cond: **Unknown**

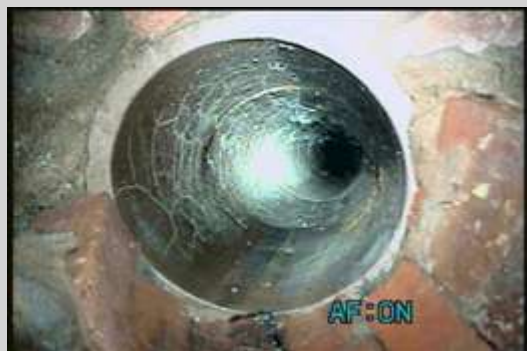
9 O'Clock Inflow

8 in. Circular Gravity Sewer
Pipe In @ 9 O'Clock

Invert Depth: **8.92** (ft.) Flow Characteristics: **None**

Infiltration: **None** Pipe Seal Cond: **Unknown**
